NEW YORK STATE
DEPARTMENT OF TRANSPORTATION

GEOTECHNICAL UPDATE REPORT SR 443 Delaware Avenue Landslide Elsmere, New York

**GEOTECHNICAL UPDATE REPORT
SR 443 LANDSLIDE
ELSMERE, NEW YORK**

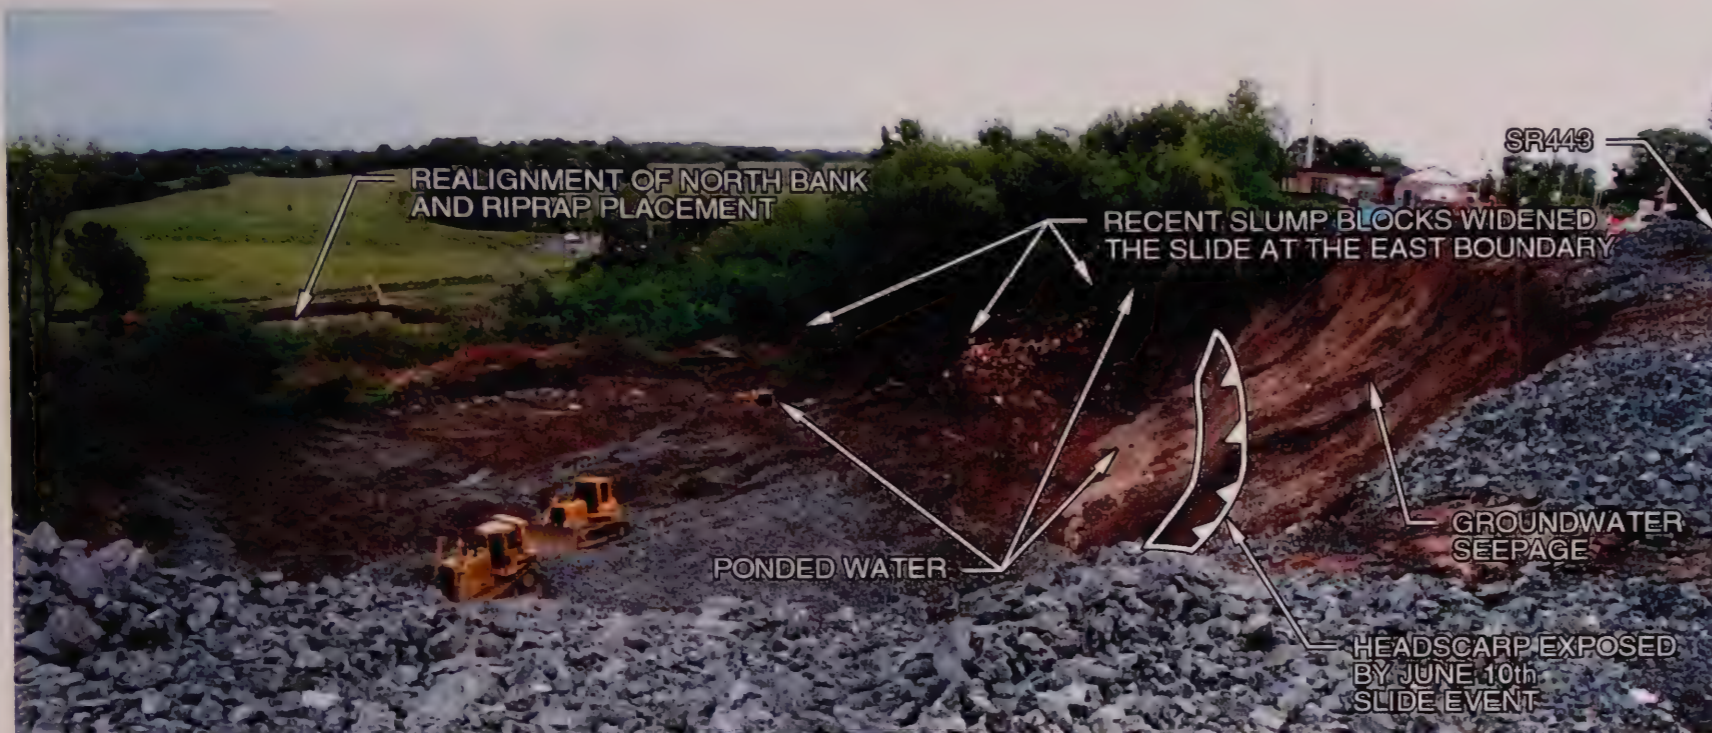
6. The central slide mass appeared to have translated horizontally about 50 feet or more. This estimate is based on the new positions of the drill rig and the upper tilted blocks of gray clay.

LOOKING NORTHEAST
AFTER JUNE 10th SLIDE EVENT

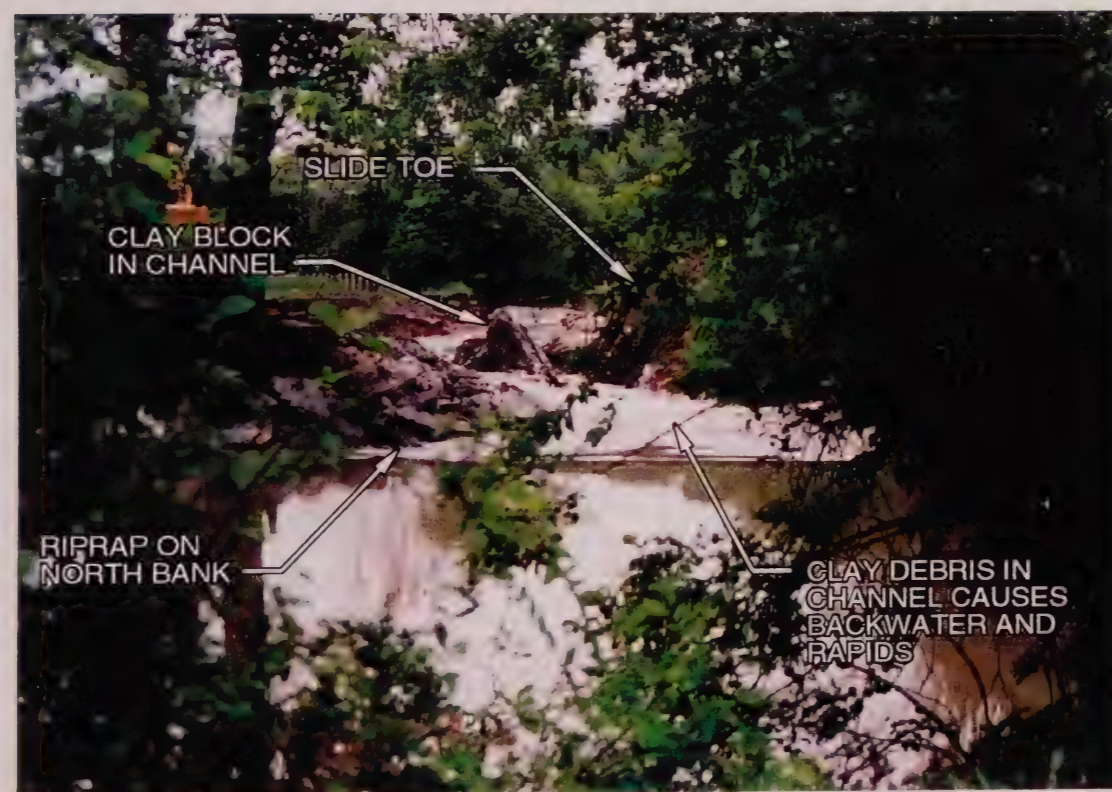
8. The City of Albany's contractor was removing slide debris from the stream channel and was placing additional riprap. The stream channel alignment was irregular because of slumped and eroded materials from the toe of the slide, and from excavations for new riprap, which extended further north midway along the slide-impacted section of stream bank. Photos of the stream channel conditions are shown on Figure 1.

LOOKING EAST
DOWNSTREAM

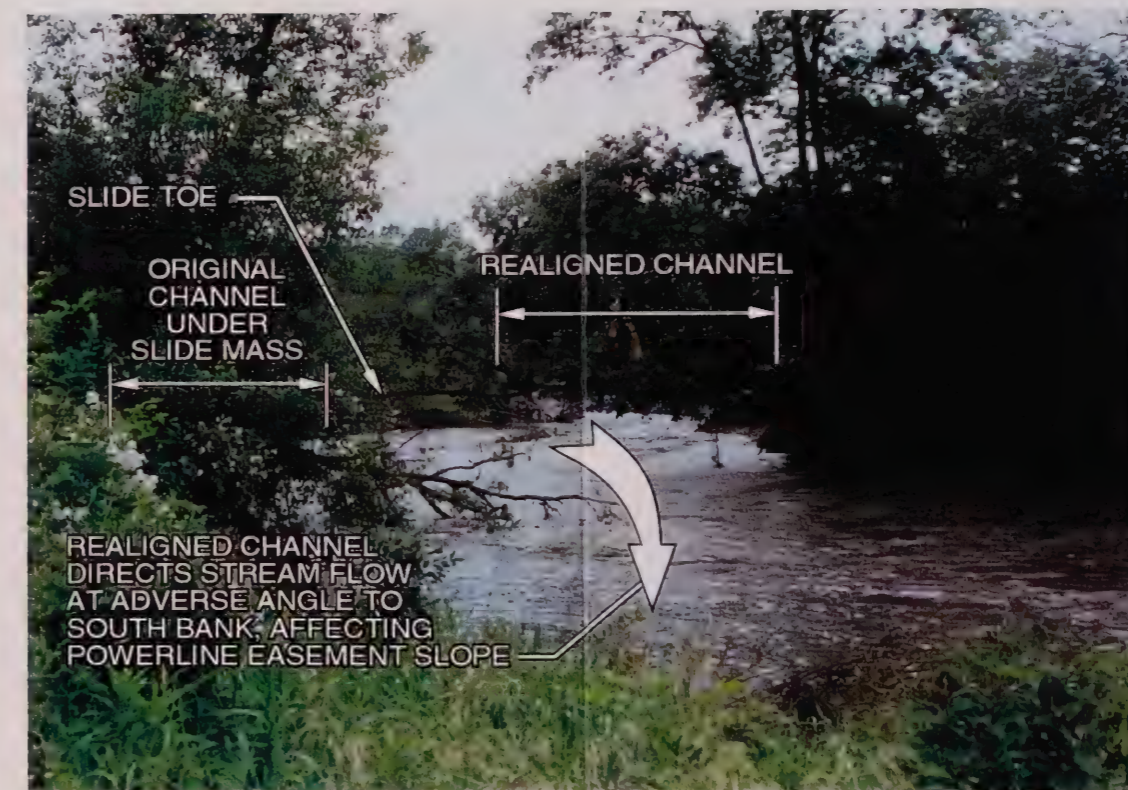
LOOKING WEST
UPSTREAM
